# Gear Test Assembly – Report of Experimental Testing – FY2020

E. Kent, H. Belch, C. Grandy, D. Kultgen, M. Weathered

Nuclear Science and Engineering Division, Argonne National Laboratory

September 2020

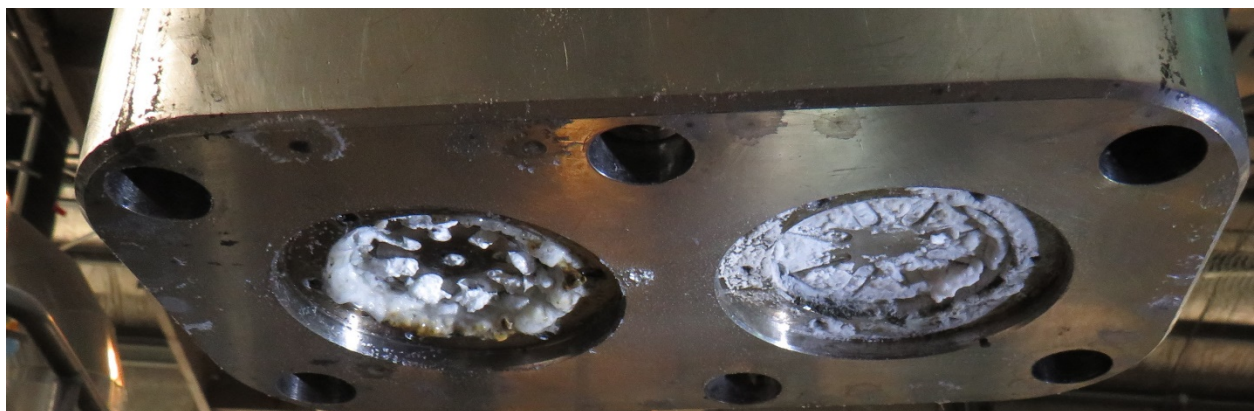
Figure 11: Image of lower sodium gearbox with bearing plates removed to show the production of sodium bicarbonate (white fluff).

While the Carbonation System was able to react most of the residual sodium away, the process led to some difficulties during disassembly. As the sodium reacts to produce sodium bicarbonate, the product expands in volume roughly by a factor of five [2]. This was problematic in places where there wasn't room for the sodium bicarbonate to expand, most notably the thin clearance gap between the gears and the shaft (Figure 13). The expansion of sodium bicarbonate between the gears and shafts tightly bound the gears to their respective shaft.

To proceed, it was decided that the sodium bicarbonate needed to be dissolved into solution to effectively free the gears. An alcohol bath was used first to react away any pockets of sodium that may have remained hidden. Next, a water bath was used to dissolve the sodium bicarbonate. Both baths used an ultrasonic cleaner with heater (Figure 14) to more effectively clean the components. Following these baths, the gears were readily removed.

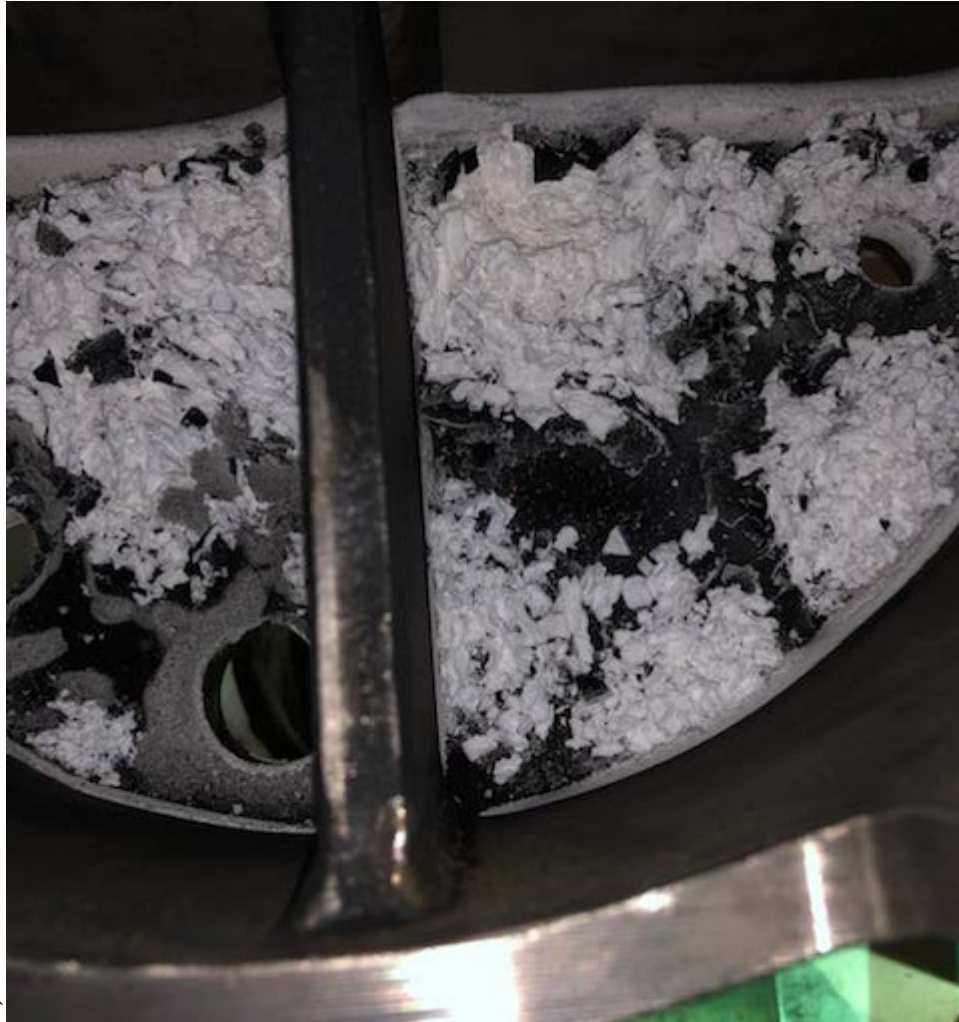
**Figure 12: Image inside the lower weldment showing the sodium bicarbonate product (white fluff) that has expanded and fallen off the GTA.**

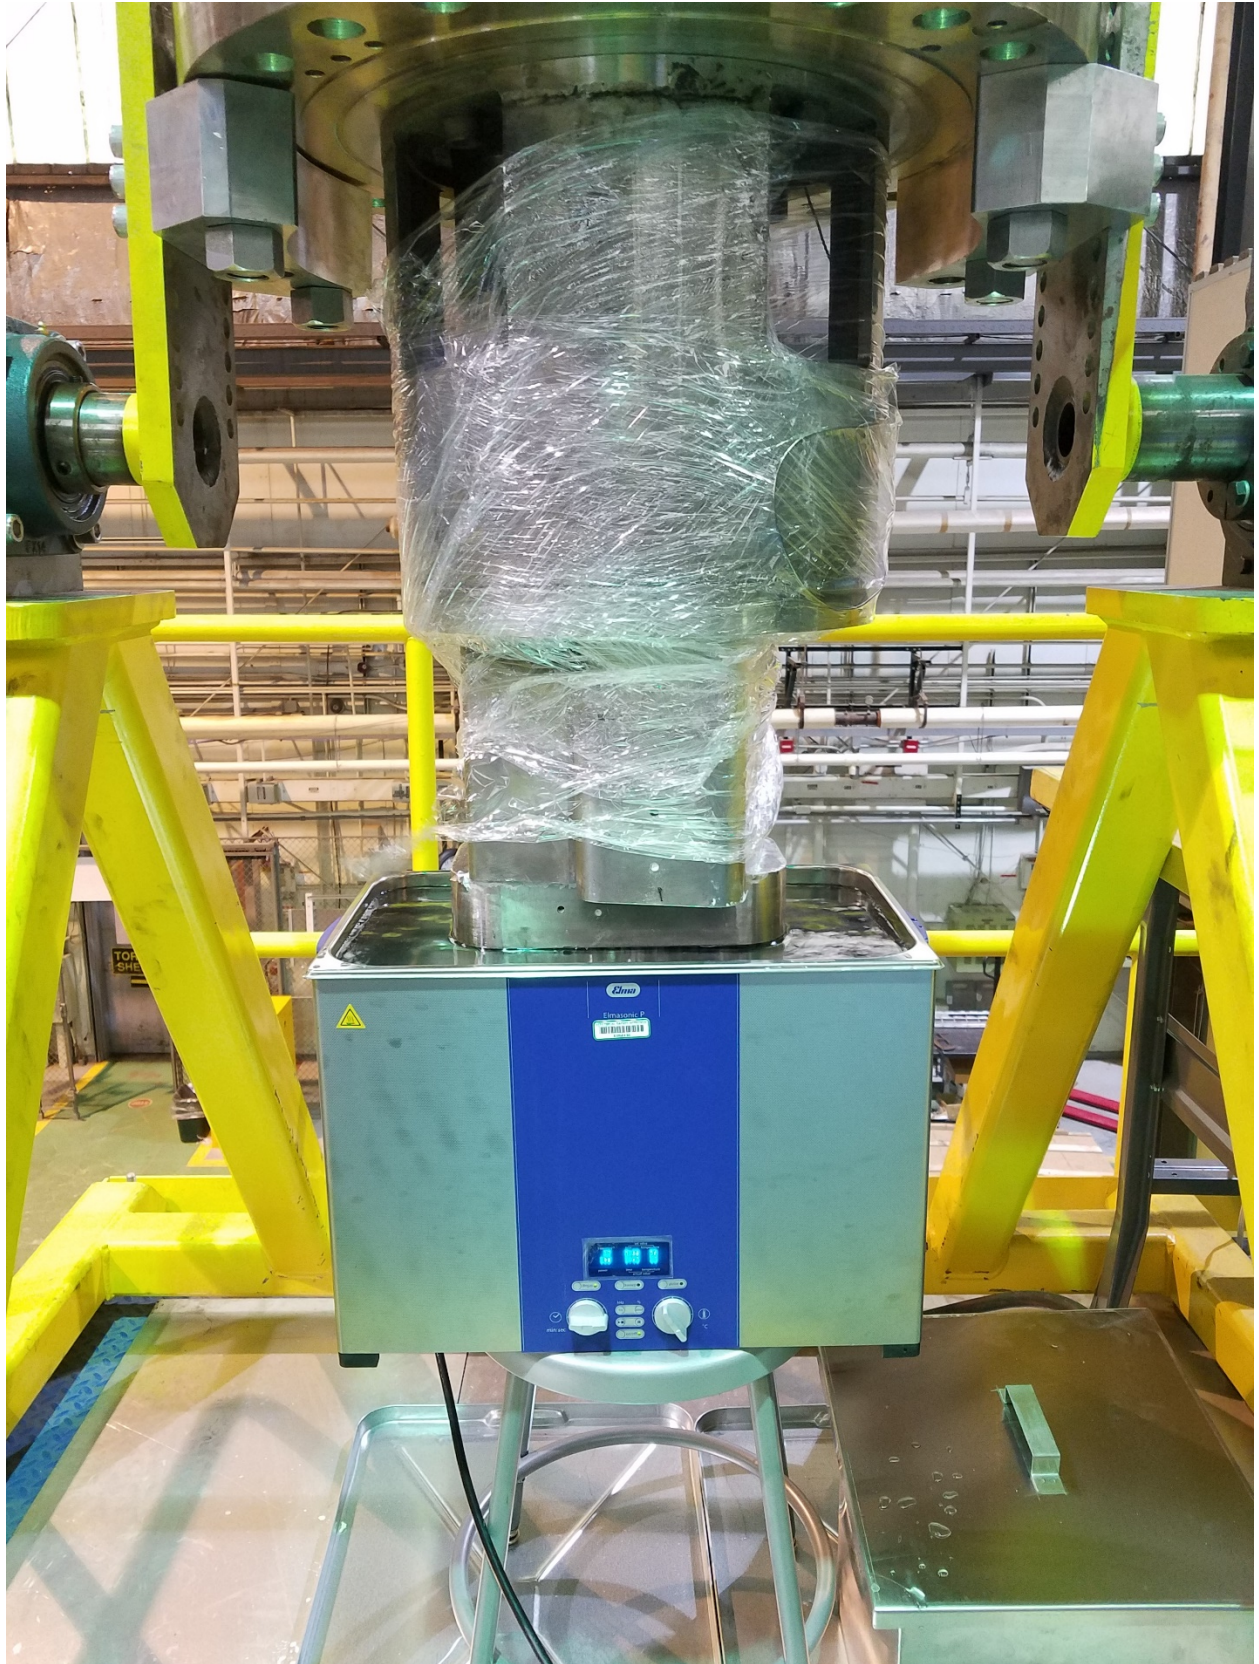
**Figure 14: Ultrasonic bath setup used to free the gears from their shafts.**

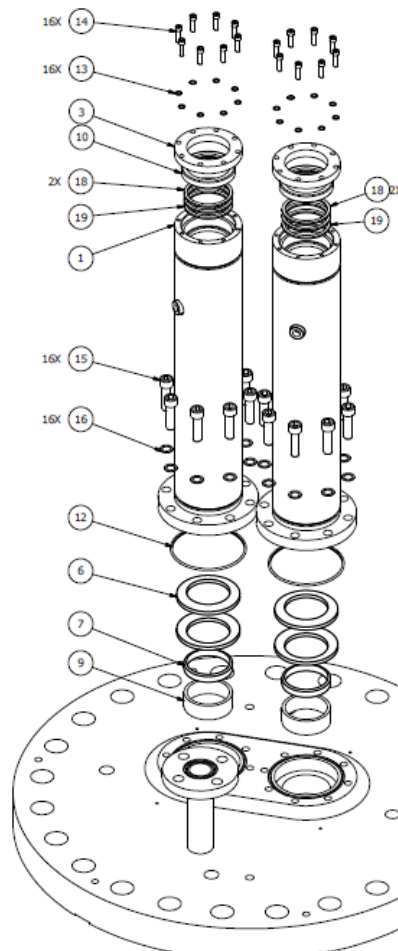
**Figure 15: Original dynamic shaft seal design.**

A few days into the first campaign, the seal chambers would no longer hold a pressure higher than the test vessel. This indicated that the graphite ring had failed. Operation continued as the O-ring seals on the top of the chamber held and this allowed for continuous flow of argon from the seal

The seal system included a graphite catch below the flange inside the gas space of the GTA. During disassembly, a significant amount of graphite was found in the catches. The catches were designed to hold  $>7\times$  the volume of the graphite rings, but fragmentation of the seal led to an increase in volume. As seen in Figure 16, the graphite reached the top of the lip and likely had some spill over into the test vessel. While a small addition of carbon to the sodium inventory is not a major concern, this issue needed to be addressed.

An additional issue with the original seal design was the required use of silicone O-ring lube for the top seals. This lube eventually made its way past the O-ring seals and travelled down the shaft. While silicone is compatible with sodium, this is a potential contamination route. Figure 17 shows the condition of the shafts during disassembly. Silicone lube is visible on the shaft, particularly where residual graphite has stuck to the lube.

While the original seal system performed sufficiently during the first campaign, a number of design changes were desired. The composite graphite rings were too fragile for this operation, and an excessive amount of silicone O-ring lubrication was used. A new dynamic shaft seal was designed to accommodate these desired performance enhancements. The new design, shown in Figure 18,

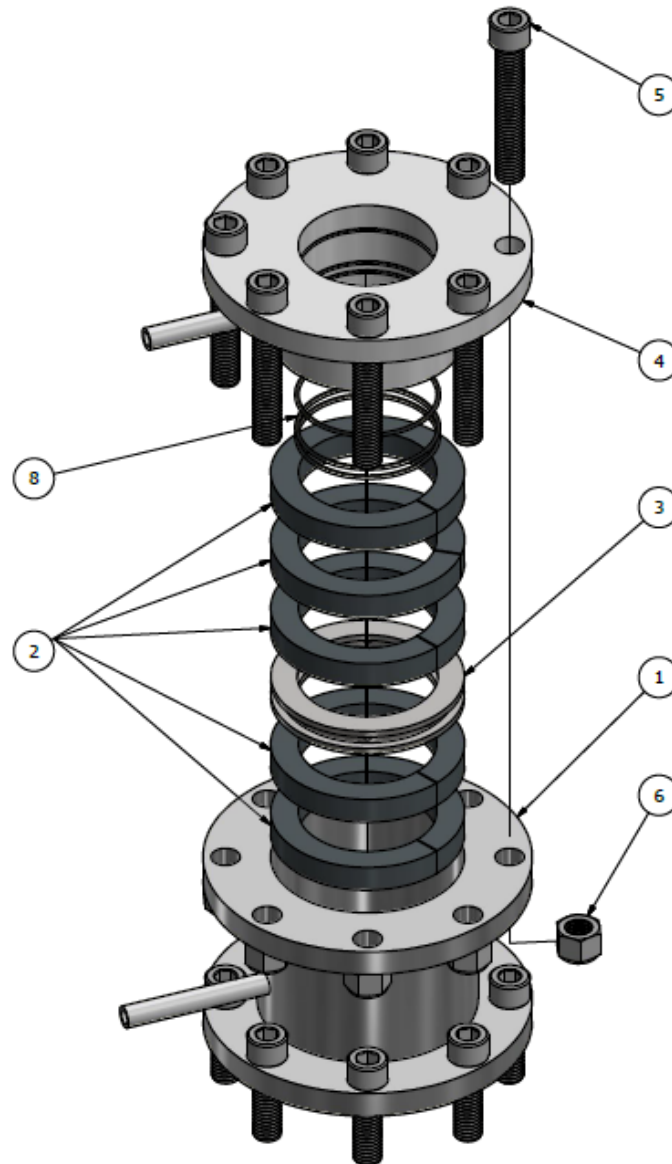
**Figure 18: Lantern Ring Seal.**

Inspection of the graphite catch during the second campaign disassembly process found a significant reduction in graphite debris. While the second campaign only operated roughly 10%

the duration of the second campaign, the reduction in graphite debris suggest the new shaft seal design performs more effectively.

consists of a body that seals to the GTA flange (#1), lower and upper braided graphite cord seals (#2), a lantern ring (#3), and a follower that is used to compress the assembly (#4). The lantern ring provides a small volume inside the seal that can be pressurized with argon, similar to the seal chamber on the previous design. Two graphite cords are used below the lantern ring and three graphite cords are used above the lantern ring. This configuration establishes a preferential leak path going from the lantern ring into the vessel, instead of from the lantern ring up past the follower and out to the environment. The use of flexible graphite cord and the seal follower allowed for re-torquing of the seal when an increase in gas flow is observed. All seal body materials are 316SS.

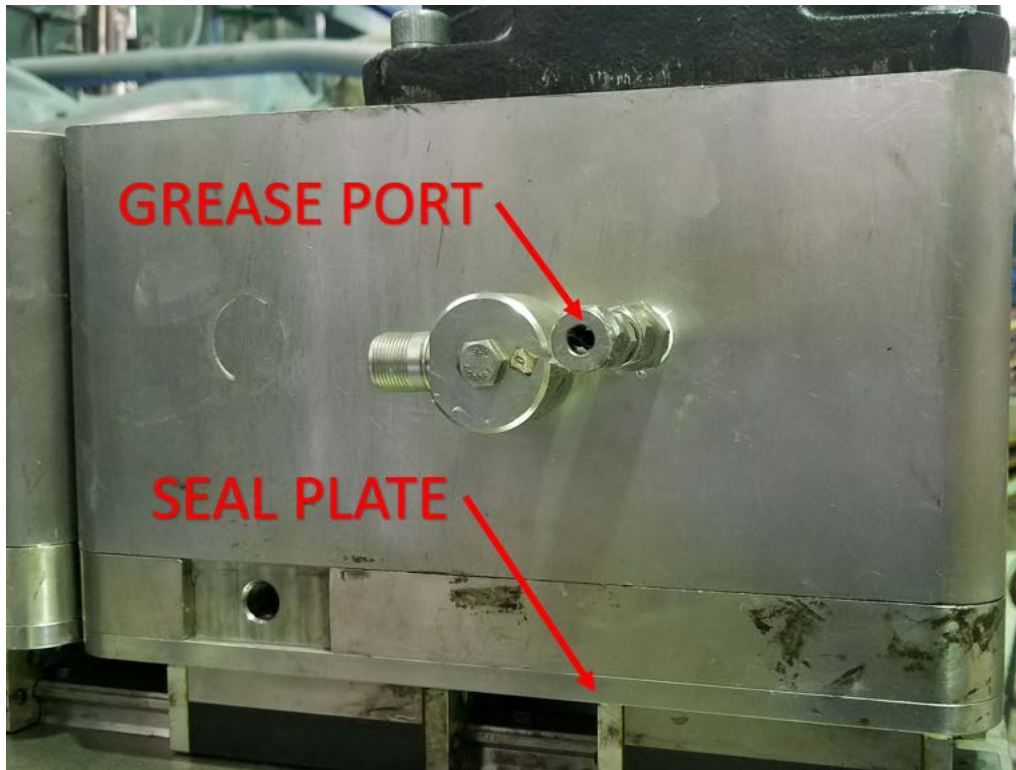
The bearings in the external gearbox that mate the motors to the drive shafts failed multiple times during Campaign #1. The lack of lubrication and excessive preload of the bearings likely lead to their early failure. To address the lack of lubrication, a seal plate and grease port were added to the external gearbox assembly. The seal plate helped to close the bottom of the gearbox, preventing grease from escaping the system. The grease port allowed for additional grease to be added to the gearbox as the system operated. Figure 20 shows the external gearbox with the modifications, and Figure 21 is a cutaway of the gearbox to show how the seal plate helps to close the bottom of the gearbox. Additionally, shims were added during assembly to prevent excessive bearing preload. These modifications were implemented during the final stages of Campaign #1, and we're kept for Campaign #2. No additional external bearings failures have been experienced.

**Figure 20: External gearbox with added grease port and seal plate.**

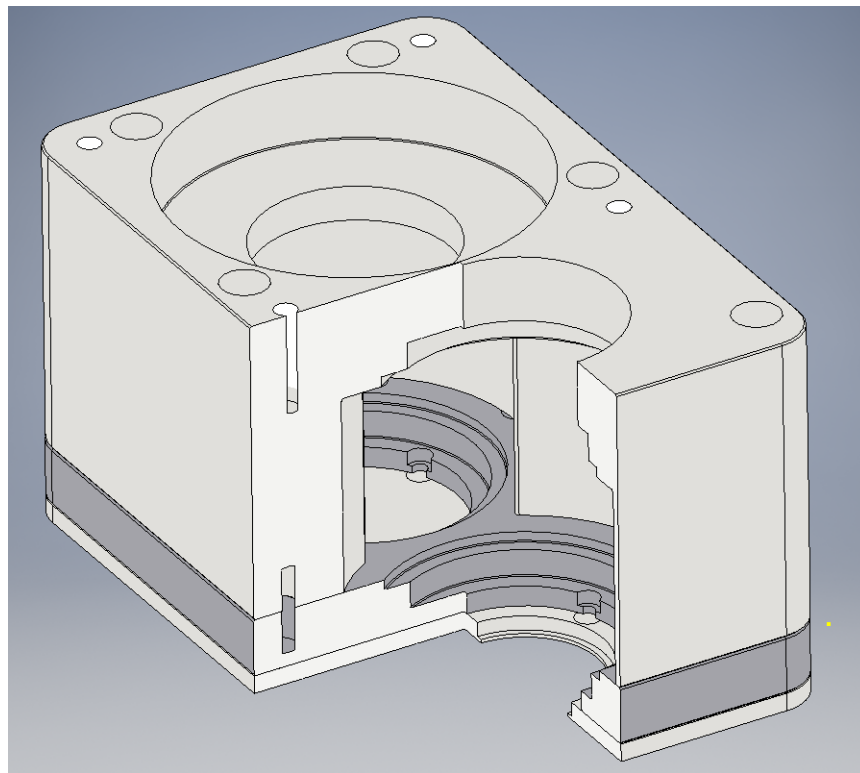
**Figure 21: Cut-away of the external gearbox to show the effect of the seal plate.**

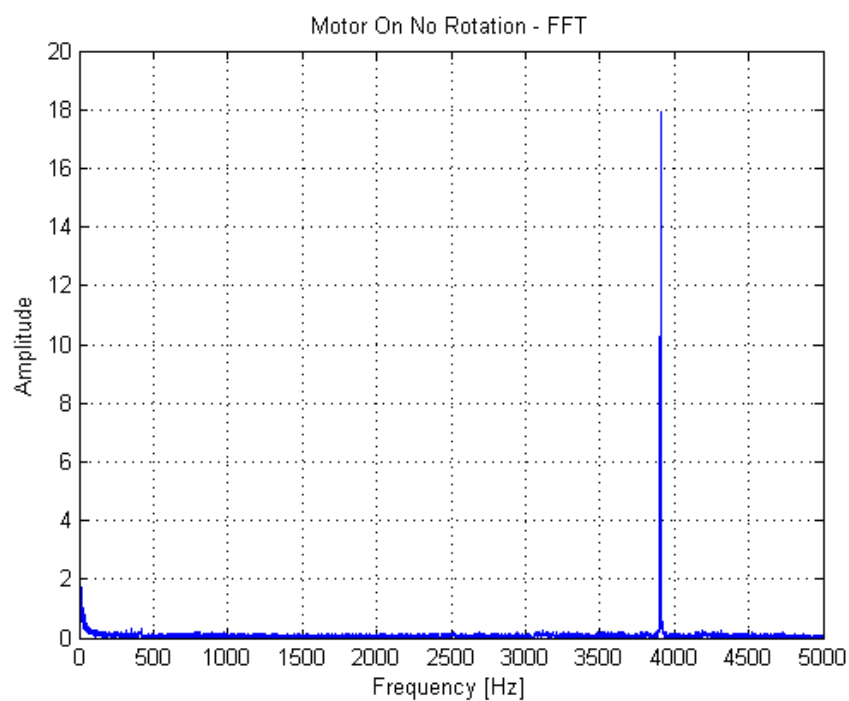
The range of the presented data (0-5000Hz) is the maximum available due to the data collection limit of the vibration sensor. A significant peak is found near 3900 Hz, and no physical phenomenon related to the gearing points to this value. The rotational frequency of the shaft is 4.17 Hz (250 RPM), and the gear mesh frequencies are 91.7 Hz for the small gears and 62.5 Hz for the large gears. This peak is likely due to the operation of the DC servomotors. Vibration data taken with the servomotors on, but the shafts not rotating are presented in Figure 25 and Figure 26. The peak near 3900 Hz is again observed, suggesting this is not related to the mechanical operation of the GTA.

**Figure 26: Frequency domain vibration data taken with the motors on, but no shaft rotation. The peak at ~3900 Hz seen in the rest of the data likely from servomotor system.**

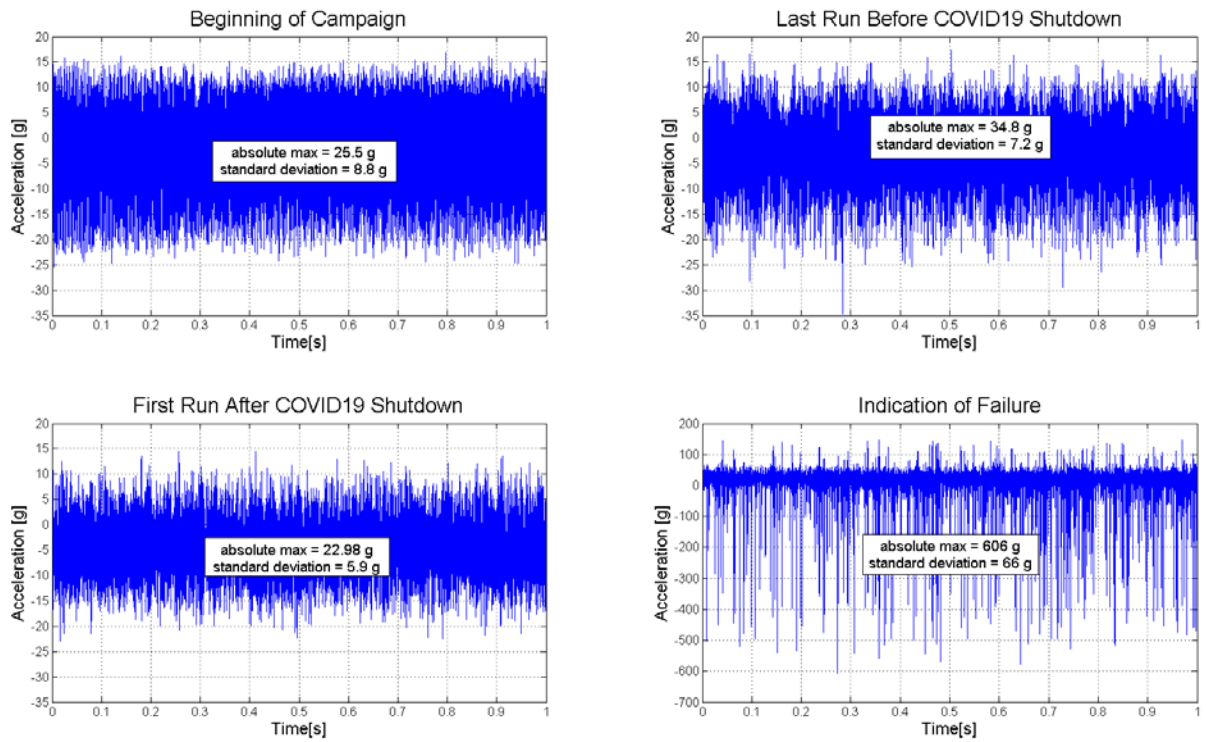
**Figure 27: Raw vibration data taken at various stages of the second campaign.**

No significant effects of the 69-day soak at temperature have yet to be identified. An obvious increase in vibration/noise is observed when comparing the fault indication data to the rest of the data presented. The max/standard deviation method of fault detection will remain in use, and development of a frequency domain fault analysis method will be pursued.

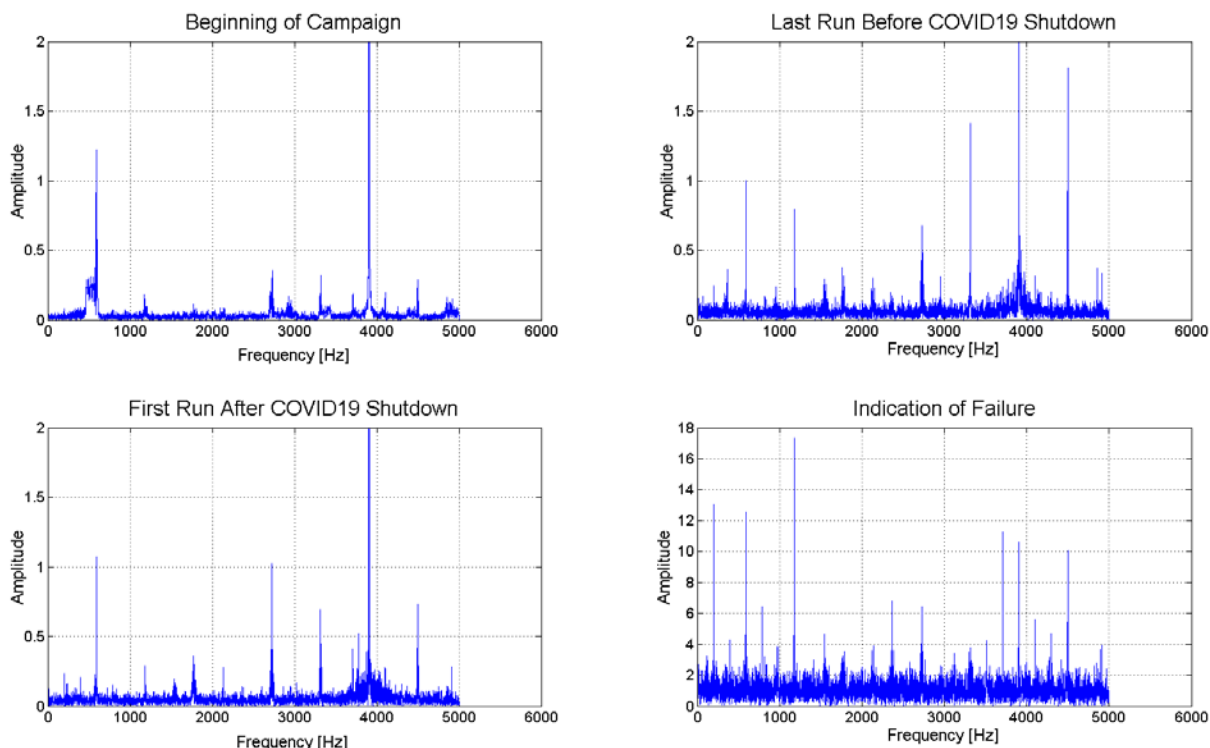
**Figure 28: Frequency domain vibration data taken at various staged of the second campaign.**

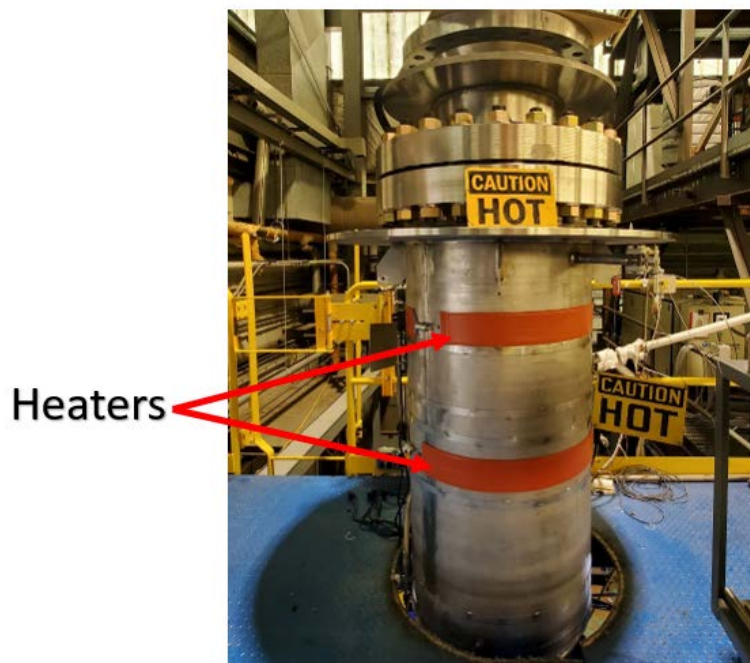
**Figure 29: Heaters added to reaction vessel to prevent condensation.**
